# Loading Bay Modifications – Lichfield Project

*Consultant-Led Engineering Solution for Damage Prevention & Safety*

### Project Overview

Amey Dock & Door Specialists delivered a consultant-led, engineering solution to address repeated loading bay damage and improve operational safety at a site in **Lichfield**.

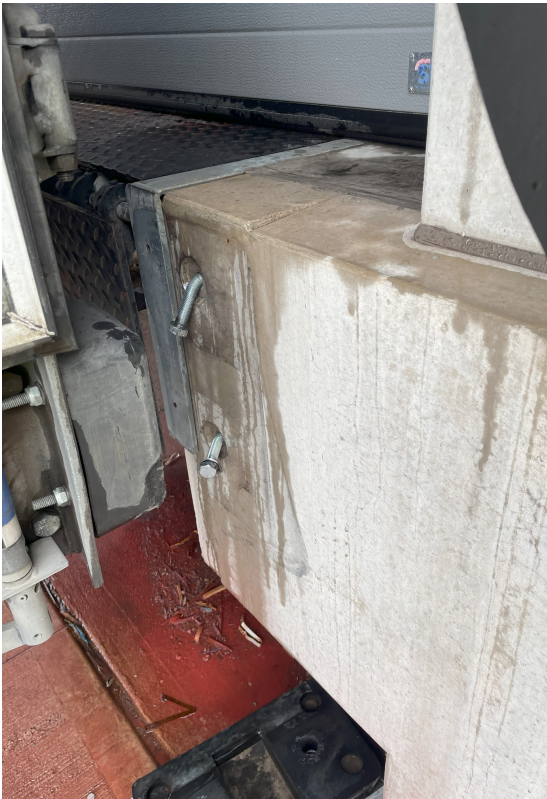
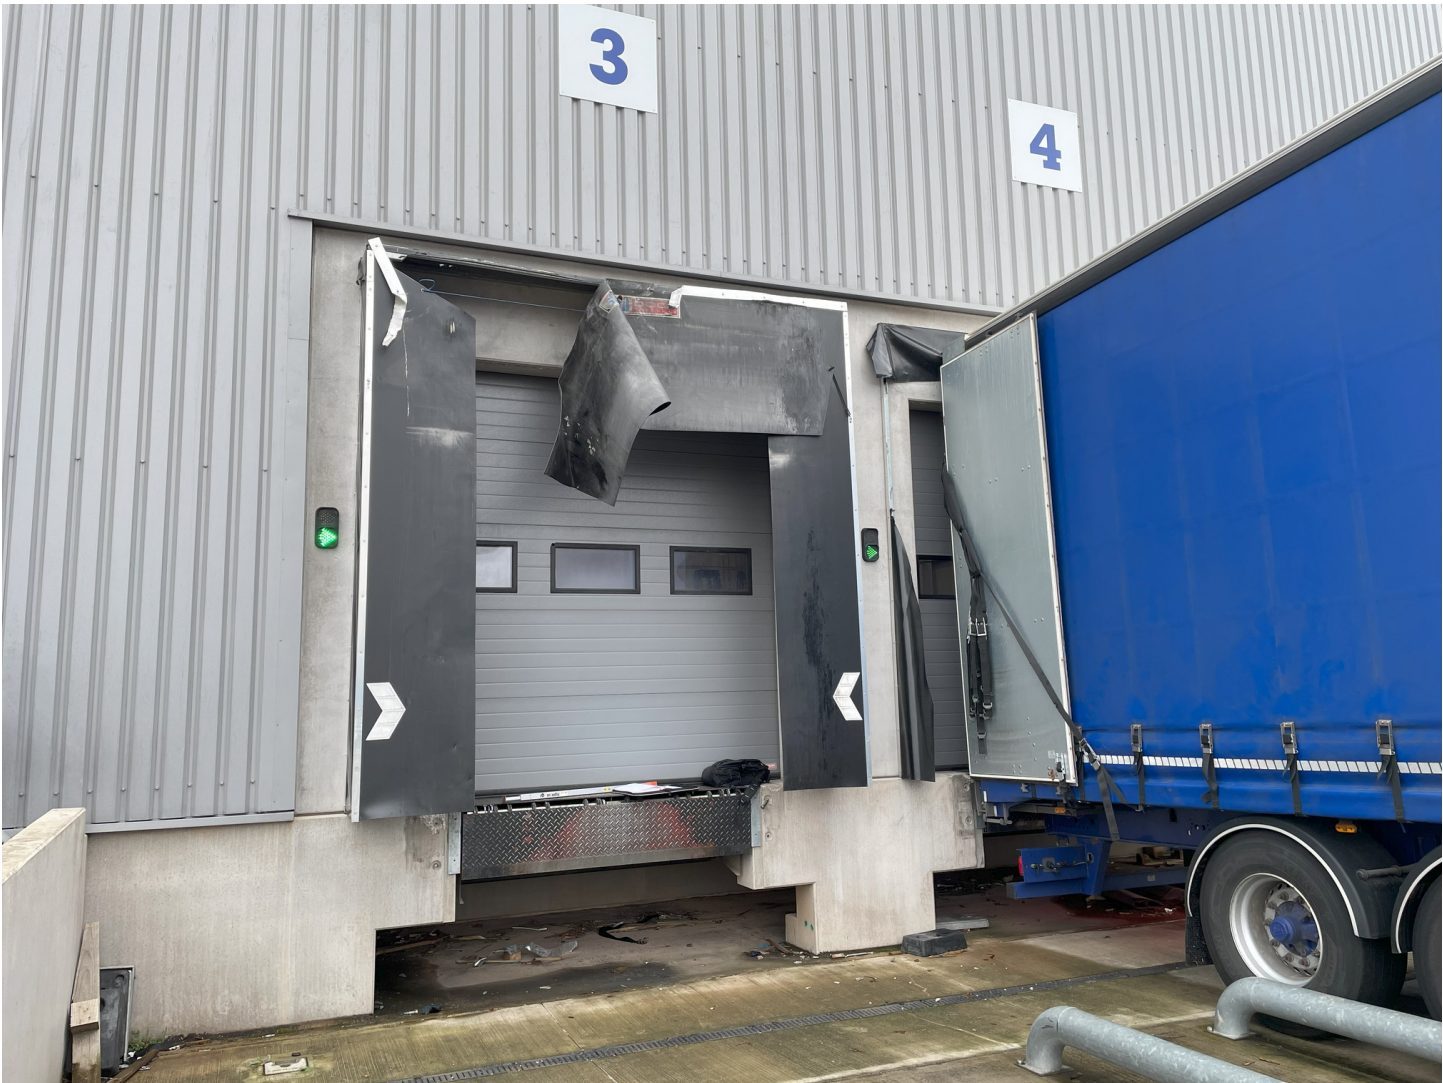
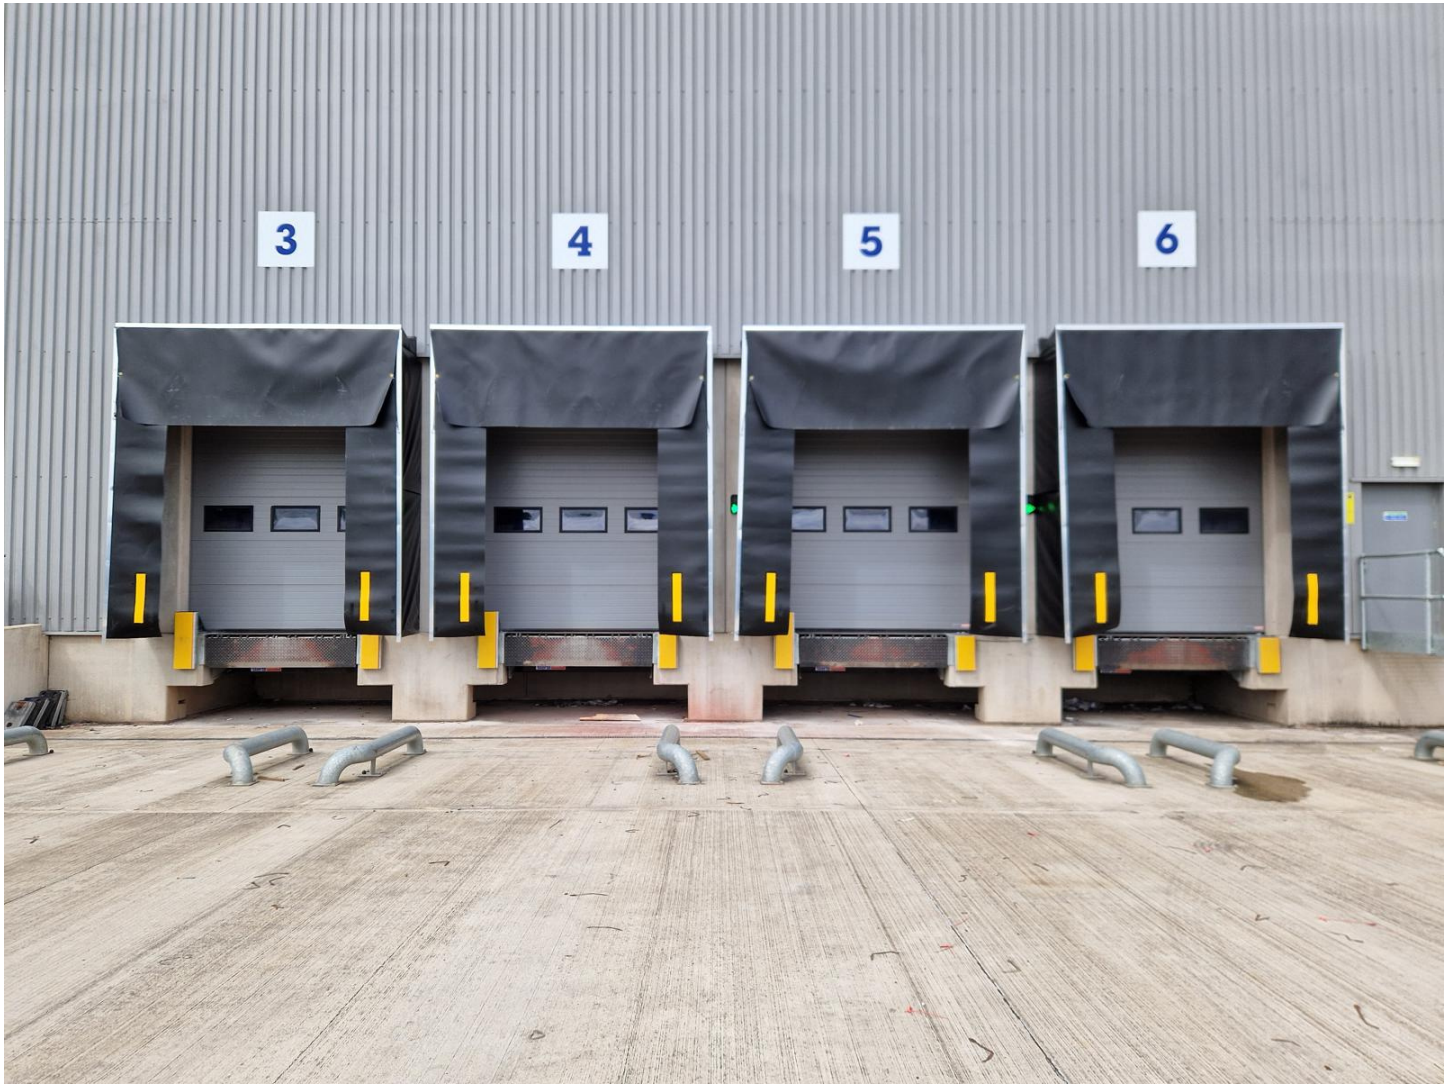
Before & After Comparison

| Area | Before | After |
|---|---|---|
| Dock shelter suitability | Short shelters were torn and crushed by taller trailers. | Taller, bespoke collapsible shelters improved compatibility and sealing. |
| Impact protection | Low bumpers allowed vehicles to ride over the bay. | Above-dock bumpers and reinforced brackets eliminated trailer override. |
| Installation constraints | Warehouse cladding prevented standard taller shelter installation. | Precision cut outs and infills accommodated cladding without façade modification. |
| Unloading & sealing | Geometry and alignment increased risk during pallet truck unloading and reduced seal performance. | Optimised alignment improved safe unloading and trailer sealing. |

- **Custom taller collapsible dock shelters** — bespoke collapsible shelters sized to better suit taller trailer profiles, improving dock sealing while reducing shelter damage during docking events.
- **Precision cut outs and infills** — shelters were manufactured with precision cut outs and infills to accommodate the low level cladding, enabling installation **without modifying the façade**.
- **New above-dock bumpers** — above-dock bumper protection was installed to prevent trailer override and manage impact loads at the correct contact point.
- **Reinforced brackets** — bumper supports were strengthened with reinforced brackets to improve durability under repeated loading bay impacts.
- **Optimised bay alignment** — alignment was adjusted to support safer pallet truck unloading and improve the consistency of trailer sealing at the dock face.

- **Bespoke collapsible dock shelters** for container and standard trailer heights.
- **Above-dock bumpers** with reinforced support brackets to prevent override and improve impact resistance.
- **Custom cut outs and infills** to accommodate low level cladding and enable installation **without modifying the building façade**.
